READY FOR *RAPID RECOVERY* & REPAIR

Herbert Hoenl, REFKO, explains how successful and long-lasting emergency rotary kiln repairs can be achieved, resulting in safer operation of the kiln until a planned shutdown can take place.

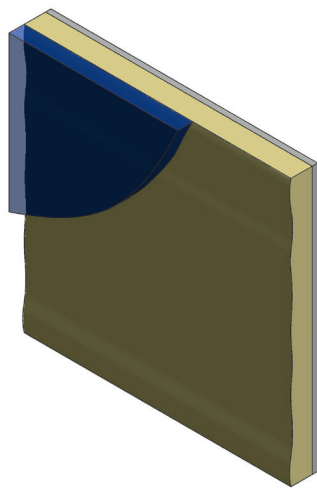
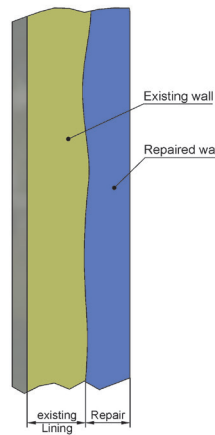
Lining sketch.

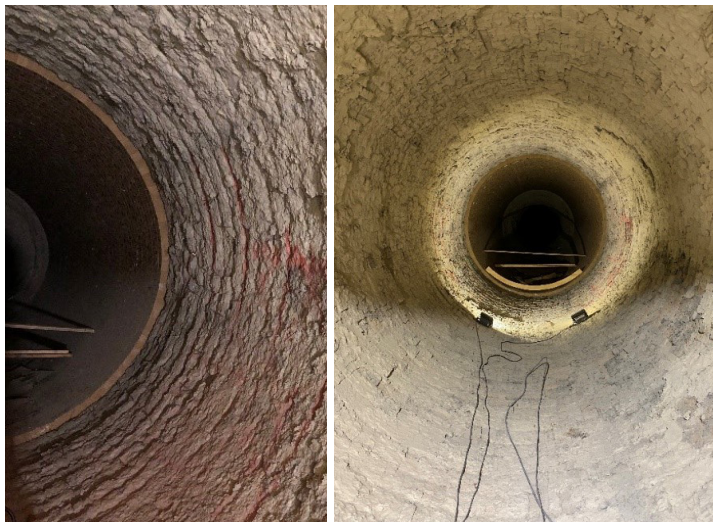
Premature wear of MgO/Spinel bricks.

In the area of the burning zone, in a kiln with a length of approximately 60 m and a diameter of approximately 4 m, a premature wear of the MgO/spinel bricks occurred. The affected areas were cleaned well with compressed air. All loose adhesions and dust deposits were also removed as much as possible by this process. Further pretreatment of the worn brick lining may also be necessary in cases such as these, depending on the damage pattern. The repair areas prepared in this way are usually divided into installation fields. Depending on the desired layer thickness, the use of anchors can also be considered. This must be decided individually 'on site'. REFKO does not recommend gun layers below 5 cm thickness.

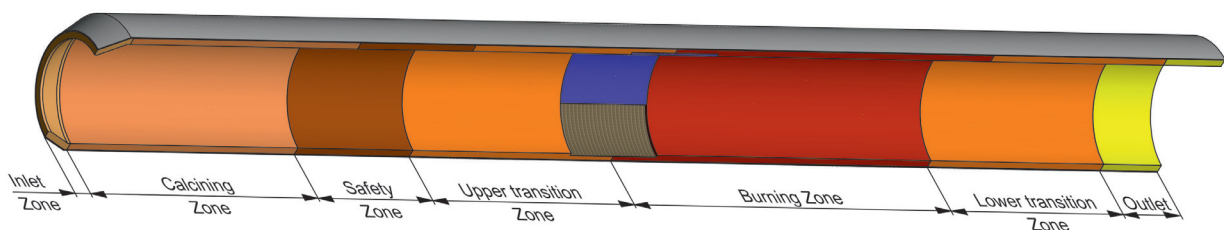
Sketch of a rotary kiln.

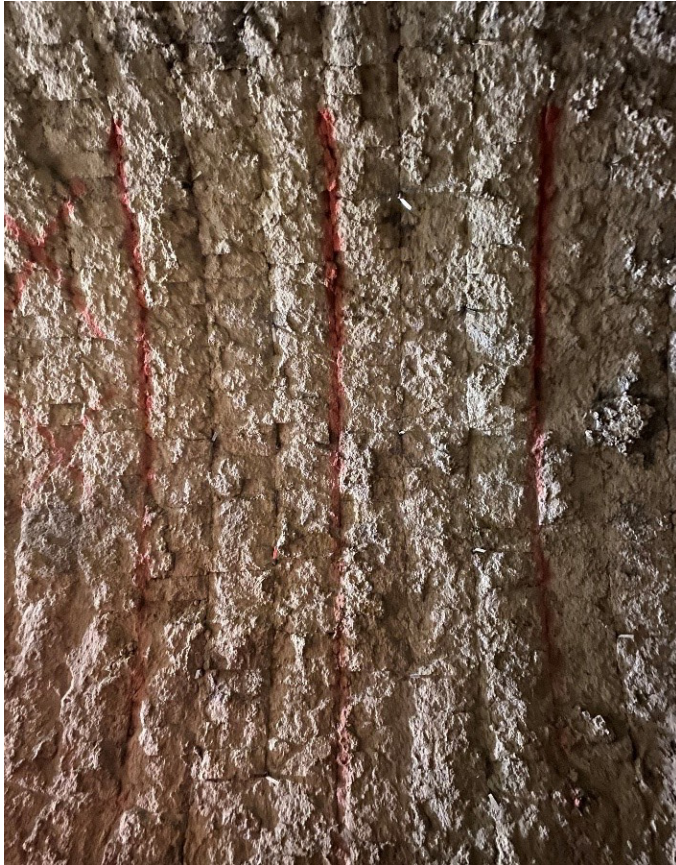
Cleaned surface and marking of the installation fields.

The installation fields are separated from each other by working joints and the joints should follow the stone joints. This is necessary to give flexibility to the mechanical loads in the heating up and operational phase, as well as the thermal expansion of the monolithic layer. To achieve optimal mechanical stability, complete rings should always be gunned. The selective repair of damaged areas is not advisable.

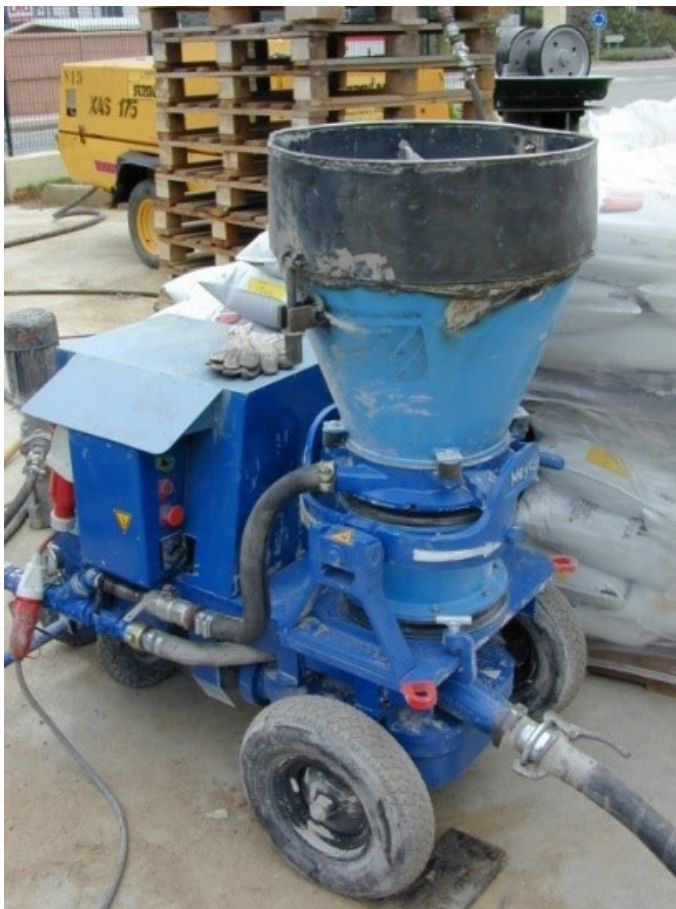
Example of a commercially available dry gunning machine.

The gunning of the REFKO Recovery MG concrete was carried out in this case with a commercially available dry- or respectively rotor-gunning machine. These machines are in use worldwide and can be easily organised for emergency repair work.

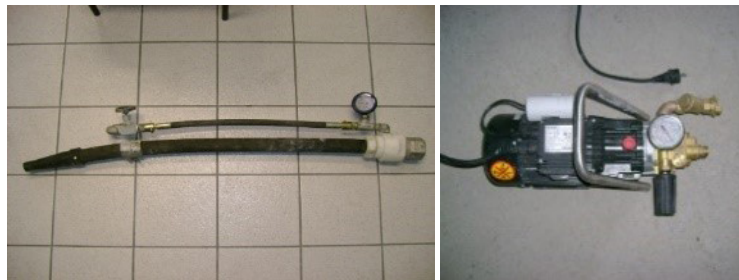
REFKO nozzle and high-pressure water pump.

The only special feature is the use of a high-pressure membrane spray nozzle, or the 'REFKO nozzle.' In combination with a high-pressure water pump, a practically dust-free gunning installation can be achieved and this special refractory concrete can be gunned with good results.

The REFKO nozzle and high-pressure water pump are now standard in many cement plants and installation companies. If, however, no REFKO nozzle and/or high-pressure pump are available, equipment will be provided by REFKO. Also, during the first installation of one of REFKO's technical service co-workers will always be on site.

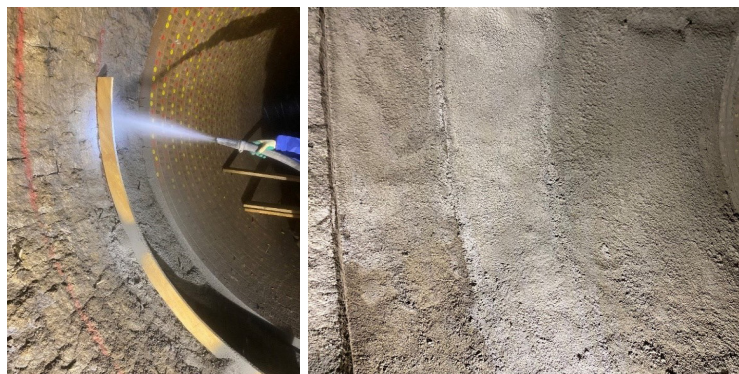
Almost dust-free gunning of REFKO Recovery MG (left) and repair zone after installation (right).

After setting, the concrete developed a stable connection with the subsoil, so that the furnace could be turned to the next mounting position without any problem.

The repair area was still completely preserved. A sintering connection with the subsoil could be detected in the post-mortem samples. No larger or more problematic formations of build-ups were detected. If a planned shutdown had not taken place, the repaired area could have lasted much longer.

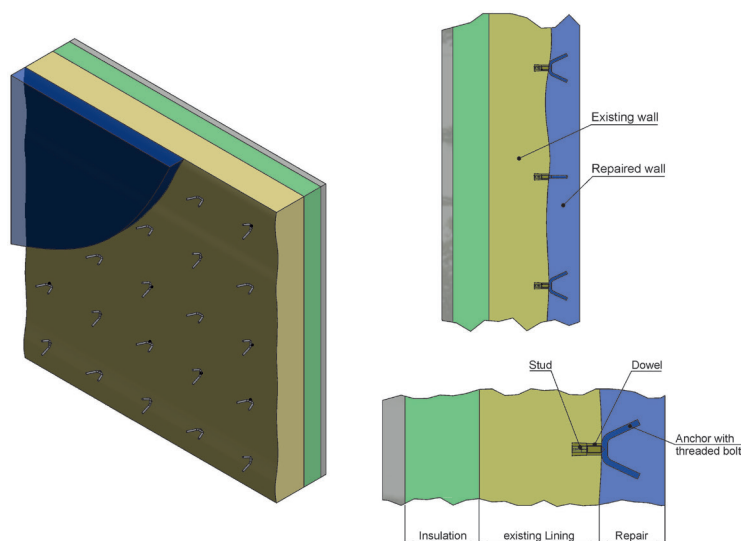
Sketch of lining, with insulation and anchors.
